Transport
Canada

TP 185E
Issue 2/2009

AVIATION SAFETY LETTER

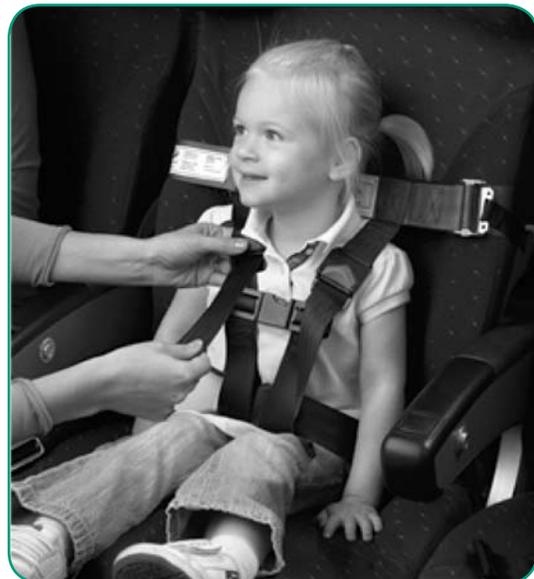
Child restraint systems are typically sold in the form of a car seat. However, Transport Canada recently accepted an alternative child restraint device called the Child Aviation Restraint System (CARES). Developed by AmSafe, CARES is a harness-type device that utilizes an aircraft passenger seat belt to secure a child's upper torso against the aircraft seatback.

one to four, weighing between 22 and 44 lbs and measuring 40 in. or less in height. The CARES device was examined by Transport Canada, and the test criteria was found to be acceptable for use on Canadian aircraft. This new restraint device weighs one pound, can be easily transported, and offers an alternative method of child restraint to passengers travelling with small children.

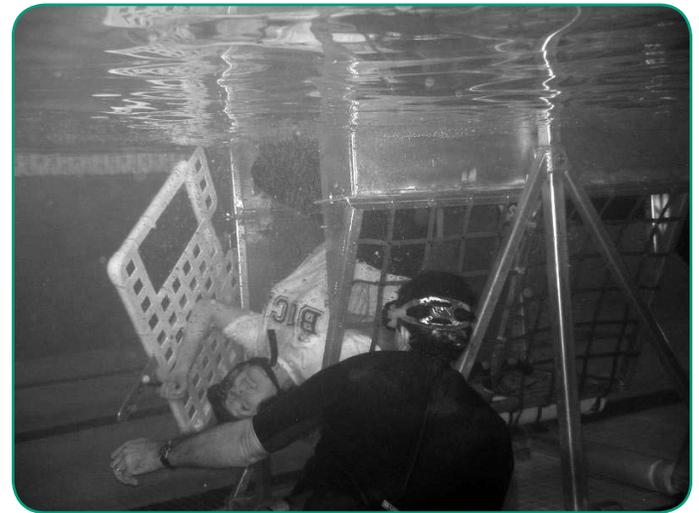
Typical underwater-egress training exercise, professionally supervised and done with portable equipment in local pools.

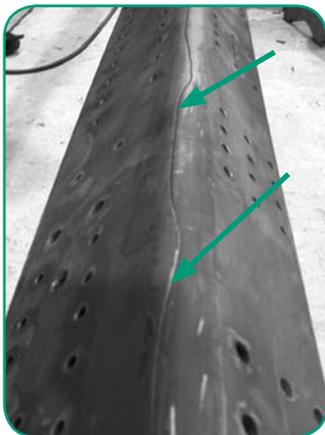
Arrows indicate crack in attach angle

On April 12, 2005, a Lockheed L382G Hercules departed High Lake, Nun., for Yellowknife, N.W.T., with four crew members on board. At 11:39 Mountain Daylight Time (MDT), approximately 10 min after departure, as the aircraft was climbing through 18 000 ft, the crew heard a bang from the cargo area. When they examined the cargo compartment, they heard the sound of air escaping from the left side of the compartment and discovered a crack estimated to be 24 in. long and approximately one-half inch wide in the left wing-to-fuselage attach angle (drag angle).

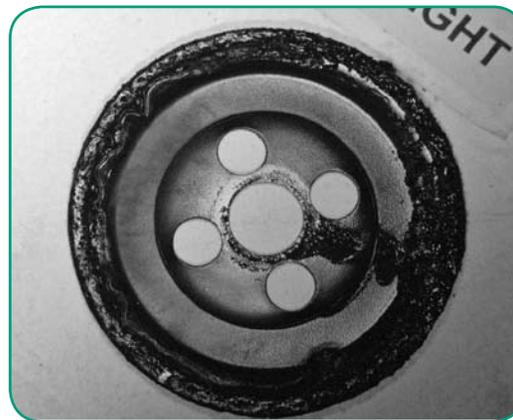
Right-engine converter plate gasket

Based on the fire pattern in the accessory section of the right engine and on the inspection and testing of involved components, it was apparent that an oil filter converter plate gasket had failed, allowing pressurized engine oil to spray into the engine compartment. The engine oil ignited, likely on contact with hot turbo-charger/exhaust components.

The failed gasket was one of a bad batch that had entered the supply system in 1999. Corrective action to remove these gaskets should have been completed by October 1, 2003, under the requirements of Airworthiness Directive (AD) 2002-12-07. However, despite the intent of the AD and the presence of other regulatory safeguards, the incorrect gasket remained in the accident aircraft's engine. The source of the gasket and its time of installation could not be determined.

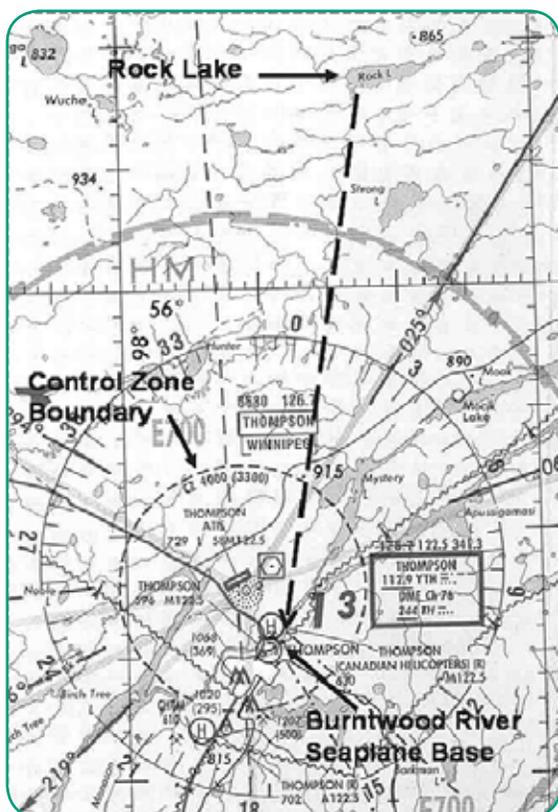
Route of flight

The final approach to landing was in a direction toward the town of Thompson on a heading of about 230°, directly downwind. Landing downwind increases the speed and, consequently, the impact forces with which the aircraft contacts the landing surface. The approach airspeed was approximately 100 mph—substantially higher than the normal approach speed of 75 mph. On landing, there was no noticeable flare before water contact.

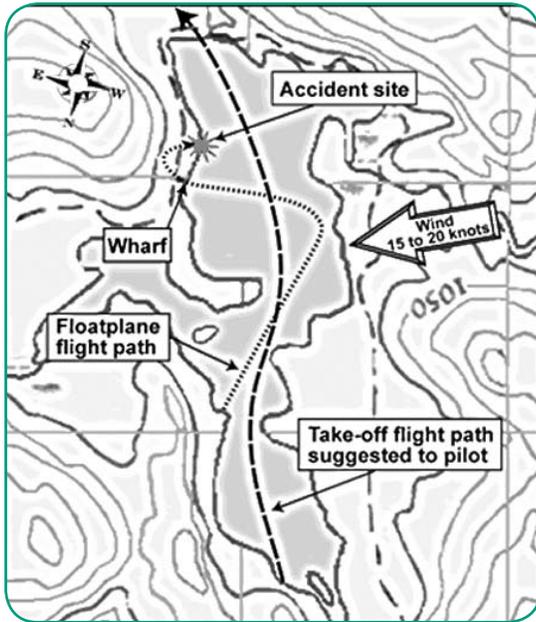
Topographic map of Pasteur Lake with aircraft trajectory before the accident

On July 8, 2006, a Cessna U206F floatplane was on a VFR flight with one pilot, one student-pilot and one passenger on board. At about 11:25 Eastern Daylight Time (EDT), the aircraft took off from Pasteur Lake, Que., and flew at low altitude over the water for a few seconds. About 30 ft above the surface of the lake, the aircraft made a 90° left turn and headed directly towards the departure wharf where the owners were. At about 100 ft above the wharf, the aircraft was seen in a nose-up attitude and appeared unstable. Shortly after, the right wing pointed towards the ground, and the aircraft pitched nose down and crashed into the trees about 300 ft farther south. A witness rushed to the crash site. Smoke was coming from the wreckage. Several minutes later, flames appeared at the right wing root. The fire could not be brought under control with a fire extinguisher, and spread to the cabin and the rest of the aircraft. The three occupants sustained fatal injuries.

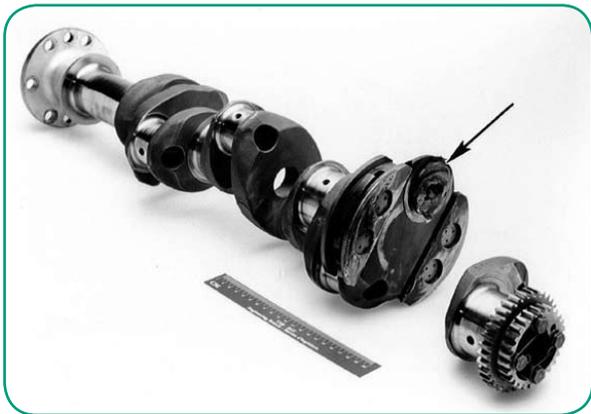
LTSIO-360 crankshaft fracture

1. A surface crack on the crankshaft, which should have been detectable during the magnetic particle inspection (MPI) procedures, went undetected during two separate inspections.
2. The crankshaft failed from the extension, in overload, of a fatigue crack initiating from an origin subsurface to the fillet radius between the No. 1 rod journal bearing and the No. 2 crankshaft cheek, resulting in the total power loss on the right engine.
3. The pilot attempted to perform a single-engine approach in a manner similar to what he had recently practiced while flying a high-performance, military-style, single-engine jet trainer. This deviation from flight manual procedures and common single-engine approach practices for multi-engine aircraft resulted in the loss of control and impact with the ground.
