AVIATION SAFETY LETTER

In this Issue...

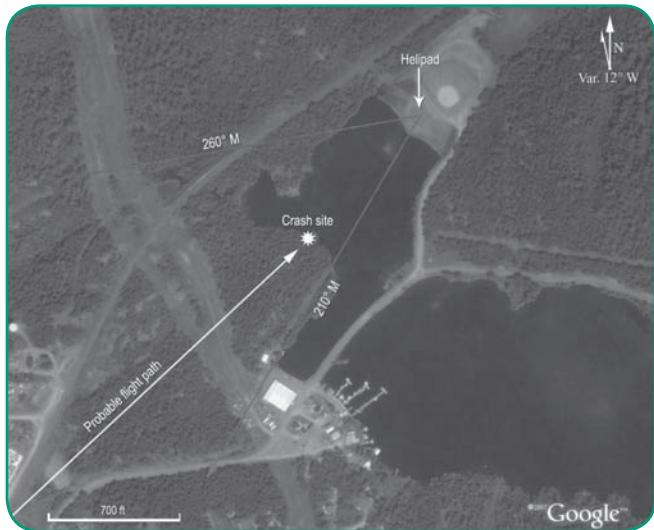
Snake Lake Helipad

The trees on the approach averaged 40 ft in height. The helicopter impacted trees that were located on the downward slope of the hill, at approximately 70 ft horizontally from the shore, where the height of the hill is approximately 10 ft higher than the helipad. As such, the average tree tops were approximately 50 ft higher than the helipad. The descent into the trees was near vertical with very little horizontal momentum and the nose of the helicopter came to rest approximately 15 ft from the shore. The helicopter's rotor diameter was 44 ft and the damage to the trees was mostly within this diameter. The rotor blades were completely destroyed. During the descent, a tree passed through the left landing gear bay, the main battery, and continued through the engine deck and exhaust collector of the right engine. There was

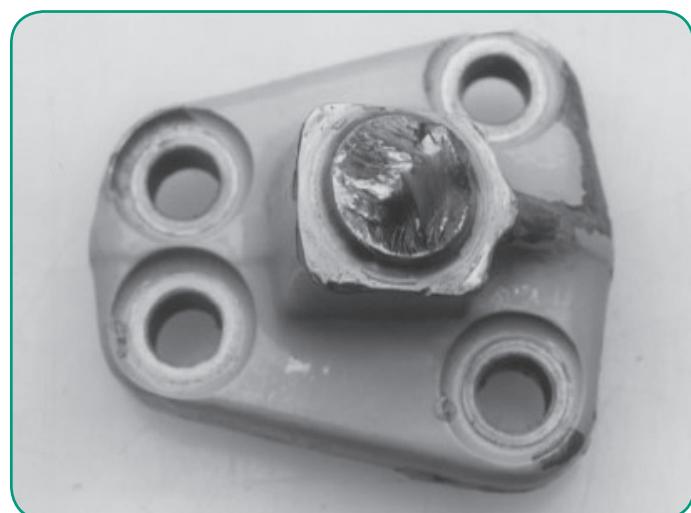
Exemplar pylon support spindle

The right-hand pylon support spindle was found fractured at the root end of the journal section, yet the spherical bearing supporting the spindle did not display impact-related damage. This indicates that the right-hand pylon support spindle was not in the spherical bearing at the time of impact. A fatigue fracture is not consistent with an impact force. The dimensional restoration repair of the spindle journal introduced a stress concentration feature at the location of the subsurface radius, which was responsible for the formation of the fatigue crack and subsequent failure of the right-hand pylon support spindle.
