TP 185E
Issue 3/2008

AVIATION SAFETY LETTER

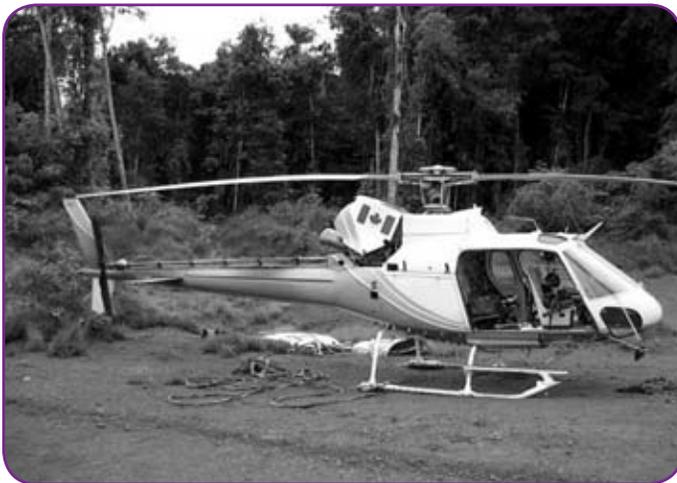
On February 6, 2005, a Canadian-registered Eurocopter AS 350 B2 helicopter was engaged in various mining support activities in the jungle and terrain in the Kamarang area, Guyana. At 17:25 local time, with a 120-ft longline attached, the pilot entered a stable, out-of-ground-effect hover to begin coiling the longline onto the ground below the helicopter. As the pilot gradually descended, and at a height of about 10 ft above ground level (AGL), he experienced significant binding in the flight controls. The pilot was unable to rectify the control binding and had considerable difficulty maintaining attitude and altitude control of the helicopter. During 15 seconds of random, uncontrolled hover flight, the helicopter turned and climbed to about 20 ft AGL, whereupon the pilot retarded the throttle lever, causing the main rotor rpm to decay rapidly. As a result, the helicopter descended quickly, struck the ground, bounced, and landed upright, causing substantial damage to the skids, the tail boom, and the main rotor head. The pilot was not injured and the impact forces were insufficient to activate the emergency locator transmitter (ELT).

1. The helicopter had a flight control malfunction and the pilot was unable to effectively control the helicopter before it collided with the terrain. The cause of the malfunction could not be determined with certainty, but was most likely a loss of hydraulic pressure.

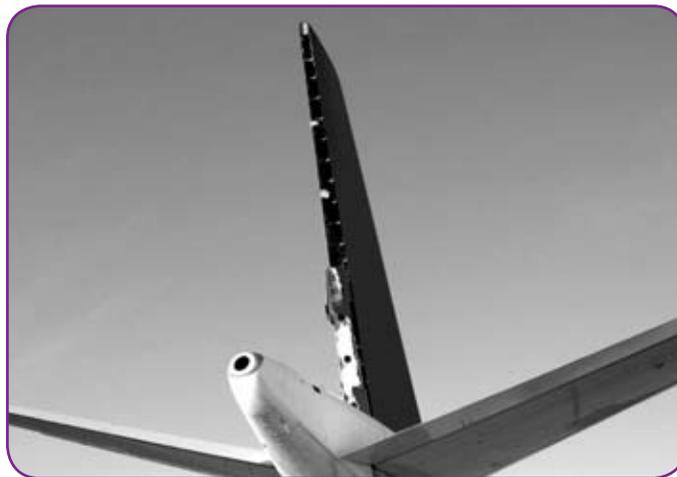
On March 6, 2005, at 0645 Coordinated Universal Time (UTC), an Airbus A310-308 aircraft, departed Varadero, Cuba, for Québec City, Que., with 9 crew members and 262 passengers on board. At approximately 0702 UTC, the aircraft was 90 NM south of Miami, Fla., and in level flight at FL350, when the flight crew heard a loud bang and felt some vibration. The aircraft entered a Dutch roll and the captain disconnected the autopilot to manually fly the aircraft. The aircraft climbed nearly 1 000 ft while the captain tried to control the Dutch roll. The crew initiated a descent back to FL350 and requested further descent and a possible diversion to Fort Lauderdale, Fla. During the descent, the Dutch roll intensity lessened and then stopped when the aircraft descended through FL280. No emergency was declared. When the aircraft was abeam Miami, the crew decided to return to Varadero. During the landing flare, the rudder control inputs were not effective in correcting for a slight crab. The aircraft landed and taxied to the gate. After shutdown, it was discovered that the aircraft rudder was missing. Small pieces of the rudder were still attached to the vertical stabilizer. One flight attendant suffered a minor back injury during the event.

1. The aircraft took off from Varadero with a pre-existing disbond or in-plane core fracture damage to the rudder, caused by either a discrete event, but not a blunt impact, or a weak bond at the z-section of the left side panel. This damage deteriorated in flight, ultimately resulting in the loss of the rudder.
2. The manufacturer's recommended inspection program for the aircraft was not adequate to detect all rudder defects; the damage may have been present for many flights before the occurrence flight.
3. This model of rudder does not include any design features in the sandwich panels to mechanically arrest the growth of disbond damage or in-plane core failure before the damaged area reaches critical size (such a feature was not specifically demanded for certification).

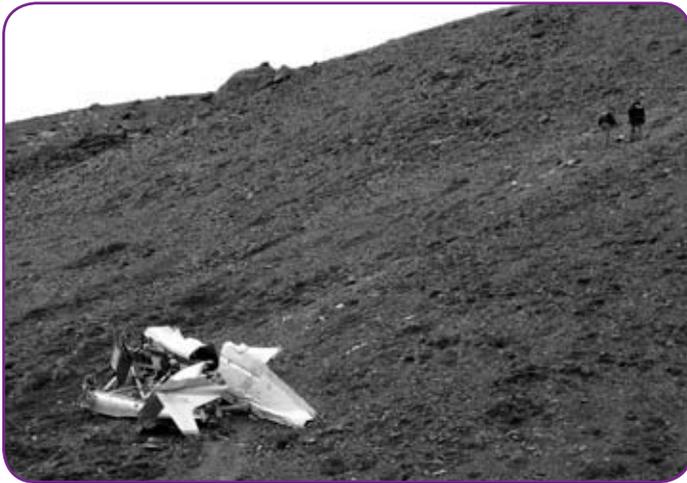
Aerial view of accident site, with TSB investigators at the approximate impact point

1. While flying in mountainous terrain, the pilot was manoeuvring close to terrain, and struck the ground at slow speed, with the aircraft in a nose-down attitude, possibly after a stall.
2. The pilot's lack of experience in mountain flying likely caused him to misjudge how close to the terrain he could safely fly. The strong wind from the southeast may have been a factor.

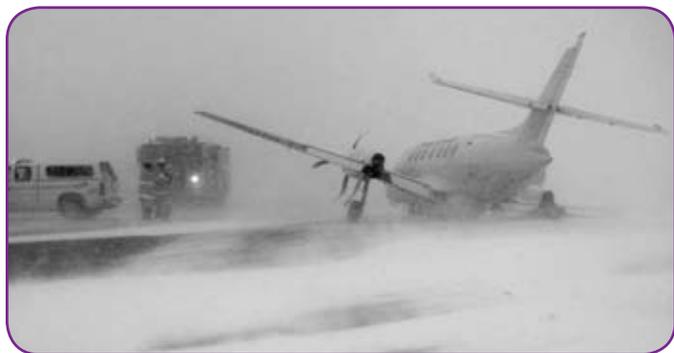
This picture taken shortly after the occurrence illustrates the poor visibility

On January 9, 2007, a British Aerospace Jetstream 3112 was conducting an instrument approach to Runway 29 at Fort St. John, B.C., on a scheduled instrument flight rules (IFR) flight from Grande Prairie, Alta. At 11:33 Mountain Standard Time (MST), the aircraft touched down 320 ft short of the runway, striking approach and runway threshold lights. The right main and nose landing gear collapsed, and the aircraft came to rest on the right side of the runway, 380 ft from the threshold. There were no injuries to the two pilots or 10 passengers. At the time of the occurrence, the runway visual range (RVR) was fluctuating between 1 800 ft and 2 800 ft in snow and blowing snow, with winds gusting to 40 kt.
