TP 185E  
Issue 4/2010

# AVIATION SAFETY LETTER

Major Accident Report: Bell 206 Down in Cranbrook, B.C.

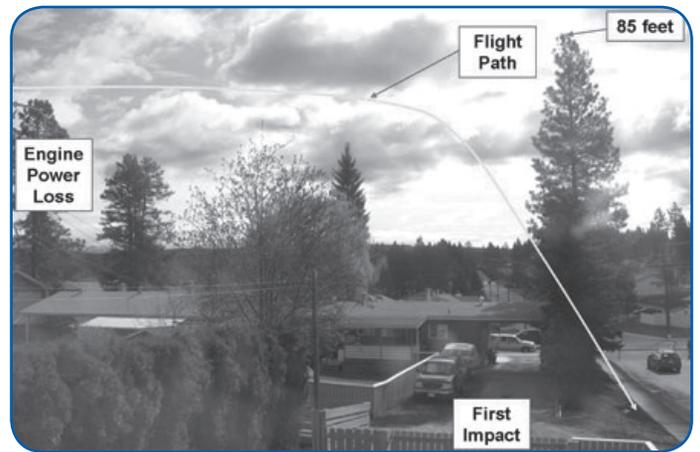
Telemetry data from the helicopter allowed investigators to recreate the flight path, depicted above.

The aircraft was flying south-southwest over 14th Avenue (midway between 7th and 10th Streets), at about 120 ft above ground level (AGL) and 25 kt, when the engine lost power. The final few seconds of flight were uncontrollable and in free-fall from about 85 ft AGL. The weather conditions did not contribute to the accident circumstances, and the experienced pilot was certified and qualified for the flight. The helicopter was certified, equipped, and maintained in accordance with existing regulations and procedures.

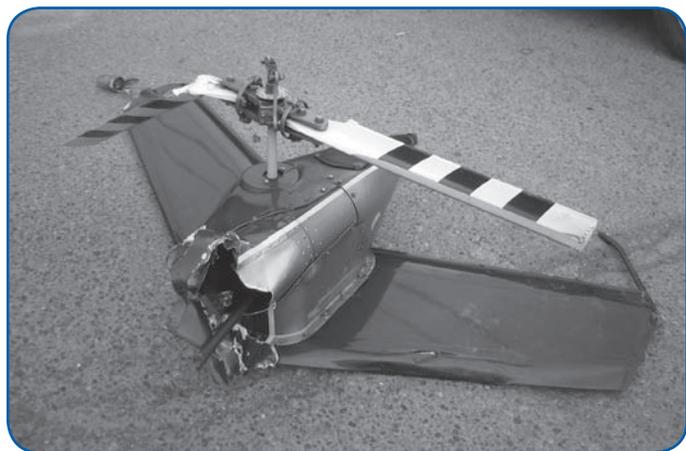
Tail rotor unit shown at the accident scene. The main and tail rotor blades were relatively undamaged.

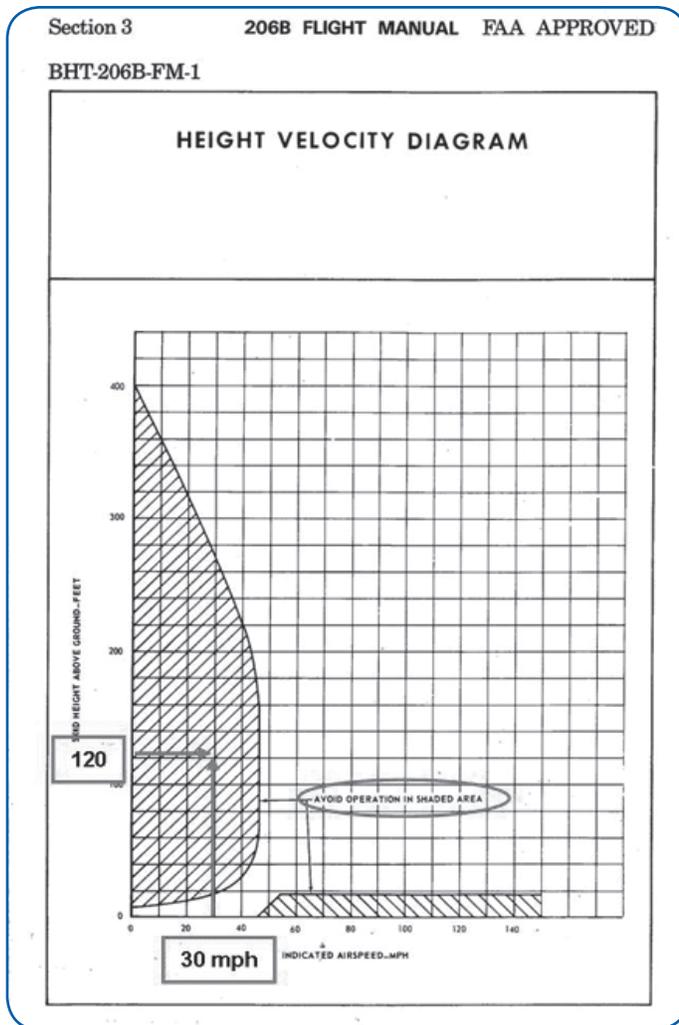
*Height velocity diagram*

The HVD shows that low altitude and low airspeed combinations present a significant challenge to pilots

in landing successfully from an event that requires an immediate landing. On the diagram, such higher-risk zones are labelled “avoid” areas and represent the worst circumstances for recovery. The accident helicopter was frequently exposed to the higher-risk avoid zones of the HVD during its passage over the built-up areas of Cranbrook.

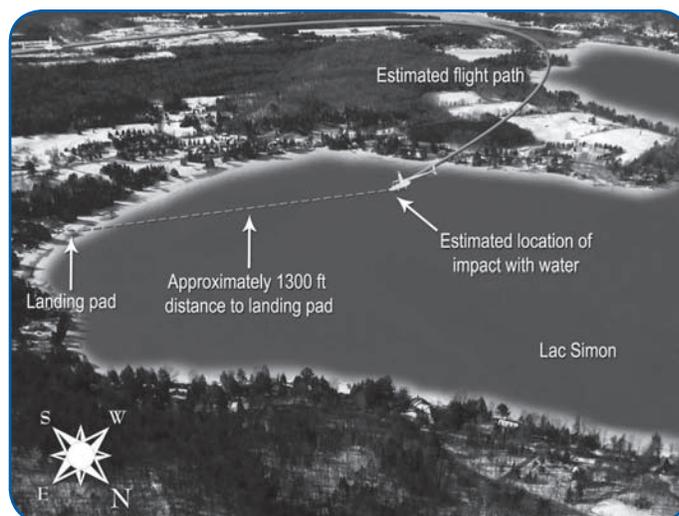
*Estimated Robinson R44 flight path before impact with water*

On December 3, 2008, at approximately 17:21 Eastern Standard Time (EST), a privately operated Robinson R44 Raven I helicopter departed Sainte-Anne-des-Plaines, Que., with the pilot/owner and three passengers on board for a night VFR flight to the pilot’s cottage located at Lac Simon, Que. The 52-NM trip was uneventful. To establish the helicopter on approach to the lit landing pad positioned in front of the cottage, the pilot turned right onto final approach at an altitude of approximately 150 ft above the lake. On final approach, the helicopter continued the descent and struck the water. All occupants escaped uninjured. One passenger successfully swam approximately 1 000 ft to shore, while

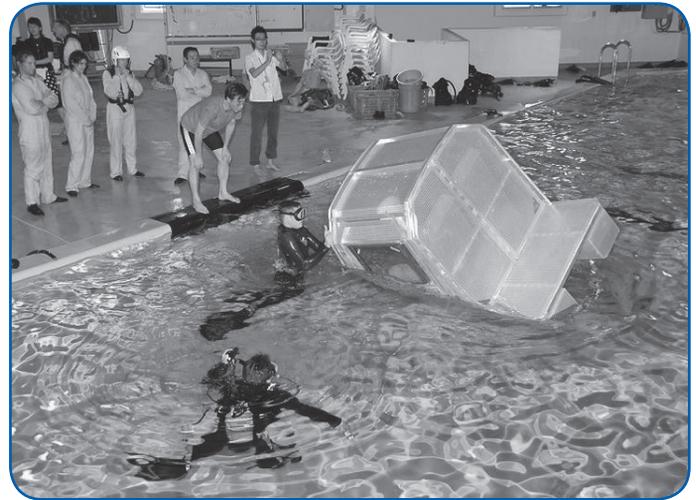
*Typical underwater-egress training exercise, professionally supervised and done with portable equipment in local pools.*

For passengers, the most difficult part of surviving a ditching accident is the underwater egress. Accident reports indicate that many people survive the initial impact, but needlessly drown because they were unable to extricate themselves from the aircraft. A study by the Transportation Safety Board of Canada (TSB) suggested that fatalities in seaplane accidents terminating in water are frequently the result of post-impact drowning. Most drownings occurred inside the cabin of the aircraft, and occupants who survived often found exiting the aircraft quite difficult. In fact, over two-thirds of the deaths occurred to occupants who were not incapacitated during the impact, but drowned trying to escape the aircraft.

Why do passengers encounter difficulties when trying to get out of an aircraft that has submerged? Panic, disorientation, unfamiliarity with escape hatches, and lack of proper training are some of the major factors that contribute to passenger drowning. During an emergency situation, rather than pausing to think, most will react on instinct and as a result of learned behaviours; if people never acquired a learned behaviour that is appropriate for this type of situation—such as the steps to follow in an

underwater-egress scenario—then the odds of reacting appropriately are much smaller. For example, when getting out of a car, most of us release our seat belt before opening the door. We do this without even thinking: it is a learned behaviour. If we are strapped into an aircraft that is sinking, a common reaction is to release our seat belt first, then try to get out. We have reverted to the learned behaviour we have acquired every time we get out of a car.
